SERVICE BULLETIN

RN SERIES 45-130 SERIAL # 1/03-12/03 DATE/NUMBER 11/03-1

SERVICE BULLETIN 11/03-1

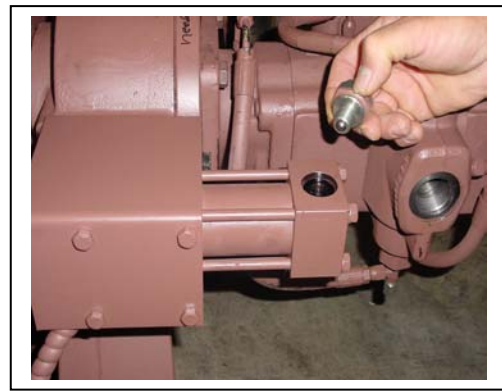
Field reports indicate that the clutch position indicator switch may be binding and causing the shaft to be gouged leading to failure of the clutch air cylinder and/or the switch. The ball on the end of the switch may be binding and not rolling up the ramp smoothly causing it to slide down the shaft leading to this failure. Inspection for this problem is as follows.

INSPECT ROLLER BALL ON
BOTTOM OF SWITCH
